Manhole Inspection Summary

Manhole # S41U__029MH

Insp Date: **2/25/09 10:20 AM**

Location Address: **1401 woodall st**

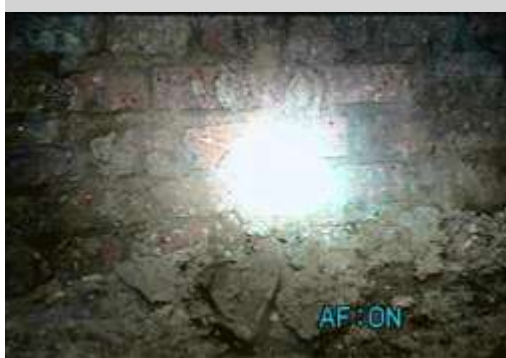
Defect 3

Condition: ☐ Sound ☐ Cracked ☐ Root Intrusion ☐ Loose Brick ☒ **Deteriorated**

Condition: ☐ Sound ☐ Cracked ☐ Root Intrusion ☐ Deteriorated ☐ Leaks ☒ **Debris**

barrel deteriorated,bench debris

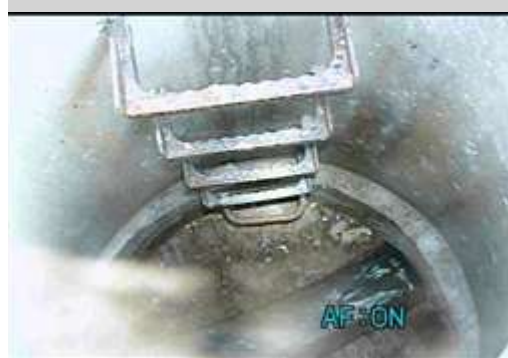
Defect 2

Steps Count: **5** Missing: **0** ☒ **Corroded**

corr steps

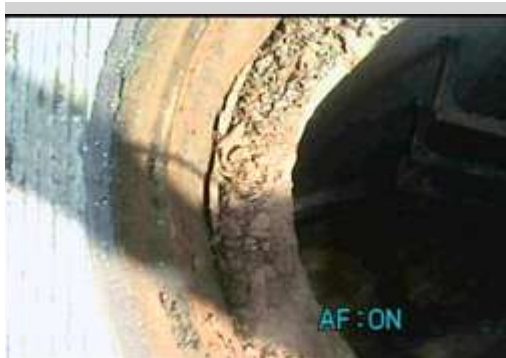
Defect 1

Frame Offset: **4** (in.) Condition: ☒ Sound ☐ Cracked ☐ Leaks

offset

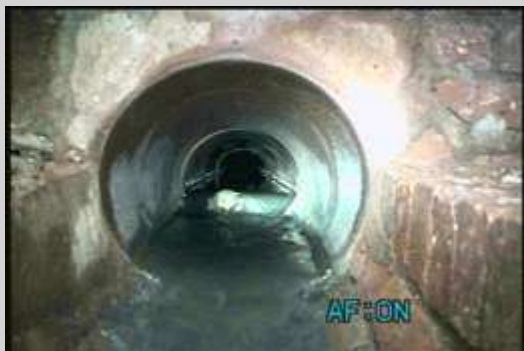
5 O'Clock Inflow

12 in. Circular Gravity Sewer
Pipe In @ 5 O'Clock

Deposits: ☐ None ☐ Mud ☐ Sludge ☒ **Debris** ☐ Grease

Silt Depth: **2.5** (in.) Deposits Extent: **Light**
